# Prospects of Using Titanium Nickelide Implants with Modified Surface in Dental Implantology

Translated from *Byulleten' Eksperimental'noi Biologii i Meditsiny*, Vol. 145, No. 6, pp. 707-713, June, 2008  
Original article submitted October 31, 2007

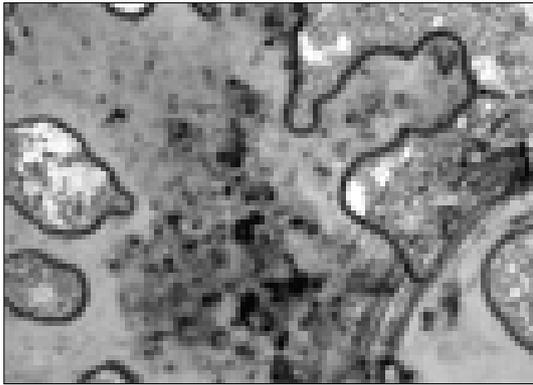
Specimen No. 1

The surfaces of implants Nos. 1 and 5 were covered ( $2/3$  of the surface) with an organic film

**Fig. 1.** Structure of glycoprotein films on the surfaces of implants removed from the bone.

presenting as grayish-black blots 1-2  $\mu$  thick with clear-cut borders. This coating was present in all crater-like depressions. One-third of the surface was covered by an iridescent film with blurred border, up to 1  $\mu$  thick.

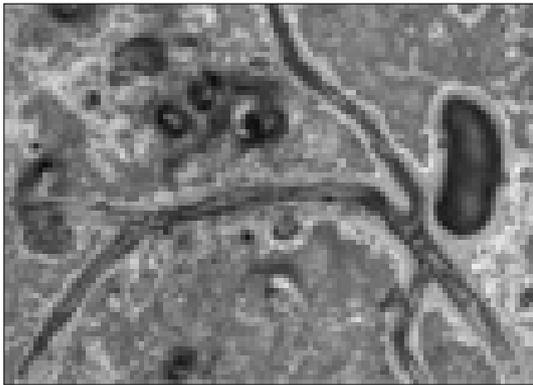
Specimen No. 2

The optical picture of film coating of implant No. 2 was heterogeneous. There were areas of round formations of 3 to 20  $\mu$  in size, foci of thick film presenting as blots, and granular areas crossed by 20  $\mu$  thick dendritic fibrils, and thick films filling the crater-like depressions.

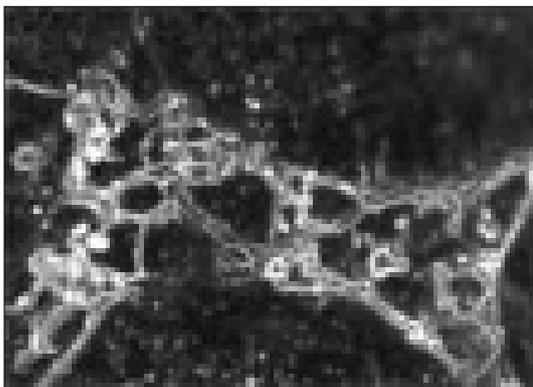
Specimen No. 3

The surface of implant No. 3 was virtually quite free from organic film coating. Small areas were

covered by a film constituting an intricate pattern or droplet-like accumulations.

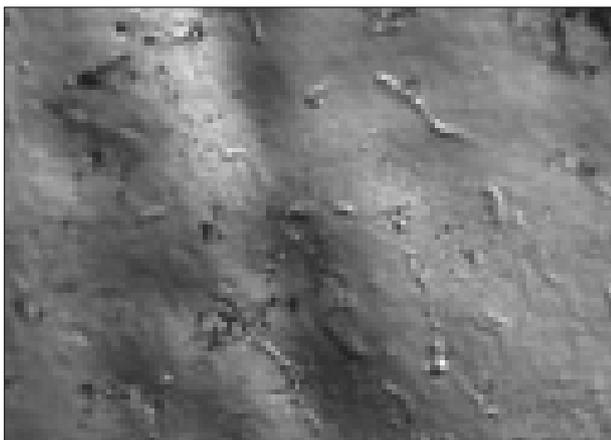
The implants surfaces before biological testing varied. Oval depressions of different diameter, depth, and density were present on the surfaces of specimens Nos. 1, 2, and 3. Crater-like depressions 30-40  $\mu$  in diameter predominated on the surface of specimen No. 1, depressions 50-70  $\mu$  in diameter on specimens Nos. 2 and 3. The number of crater-like depressions 1-2  $\mu$  in diameter was the same on the implant surfaces. The surface relief of samples treated by an electron beam has formed during rapid solidification from the liquid phase (a thin layer of the implant material melted by the electron beam).

Honeycomb surface relief of sample No. 4 was due to structure of titanium nickelide alloy with high-temperature shape memory effect. At 25°C this alloy was in the martensite state with B 19' martensite structure.

Fig. 2 (a). Implant surface before *in vivo* experiment.

Comparison of the surfaces of specimens washed from organic films showed that pitting corrosion was the most characteristic of all specimens from titanium nickelide alloy with surfaces modified by different methods: it was detected on specimens Nos. 1 and 2 as etching depressions (zirconium ion modification of surface). Specimens Nos.

3 and 4 exhibited the best corrosion resistance. Despite morphologically developed intricate surface of specimen No. 4, which was in a martensite state, there were just rare traces of pitting corrosion, no corrosion processes being detected at the periphery of the martensite domains.

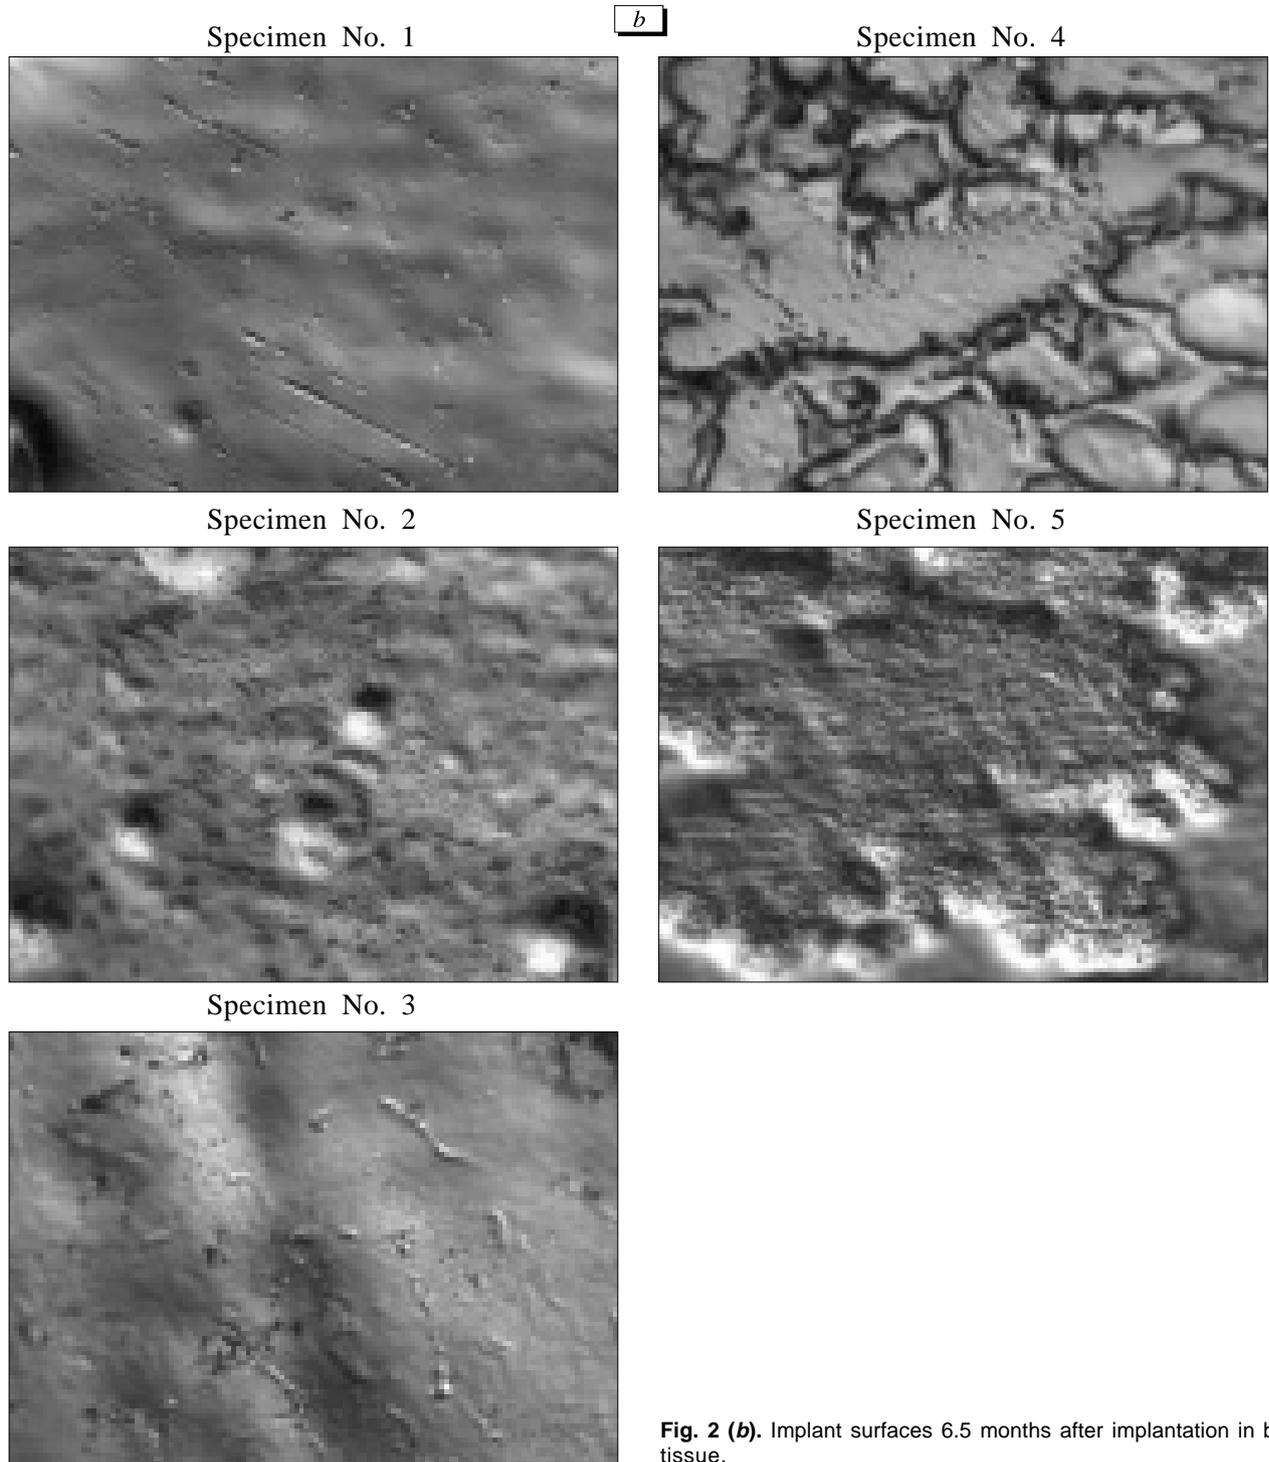
Corrosion presenting by erosion foci was seen on the surface of implant No. 5. Obvious pitting

corrosion with high density of etching pits, which fused and form a deeper corrosion relief (depressions) was seen in such a spot (Fig. 2, a and 2, b).

**Fig. 2 (b).** Implant surfaces 6.5 months after implantation in bone tissue.

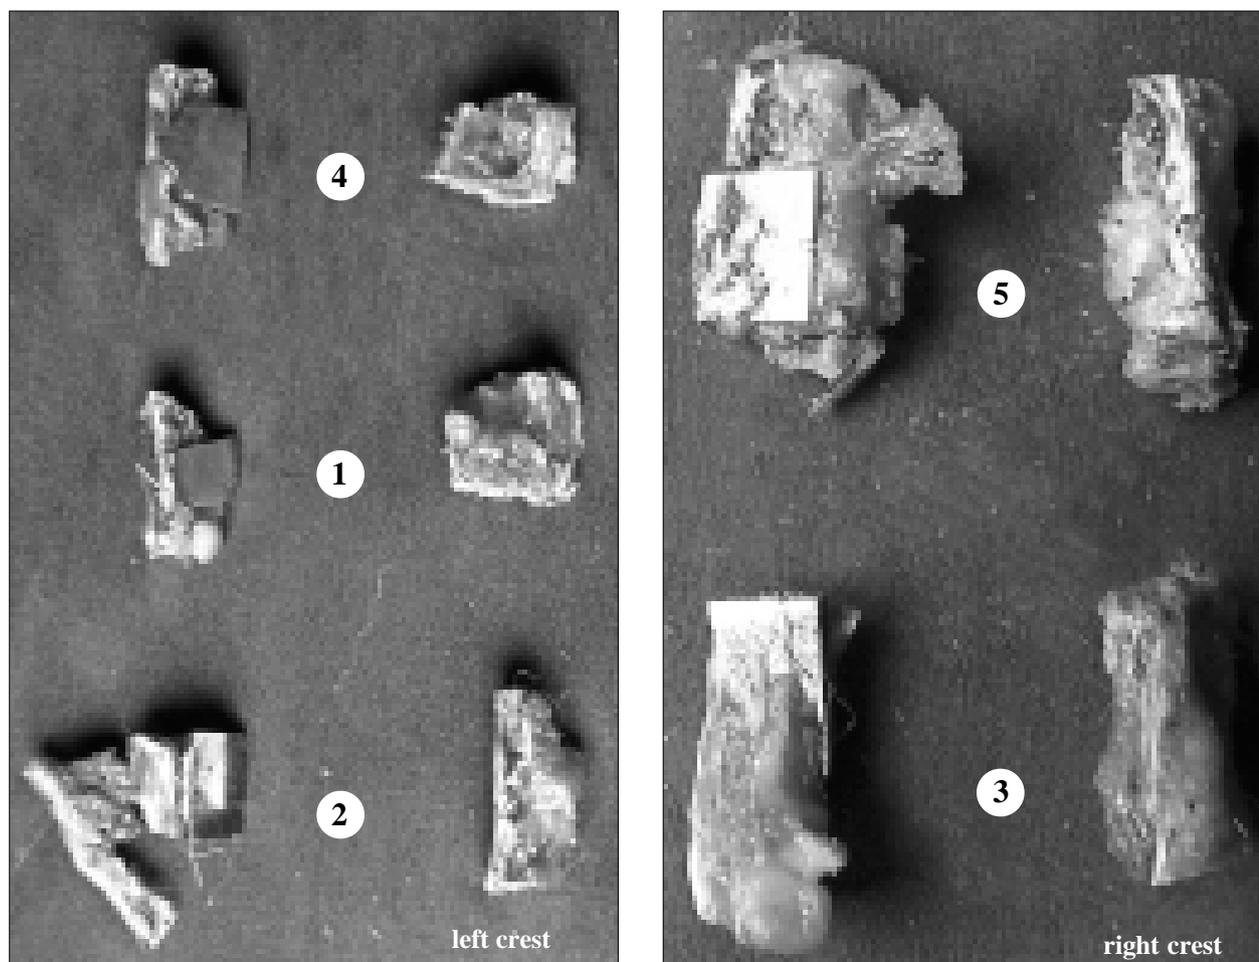
Fig. 3. Macropreparations of bone blocks with the adjacent implants.

Tissues formed around the implanted specimens differed at the level of visual inspection (Fig. 3). Implants Nos. 4 and 2 were surrounded by normal mineralized bone. A rough fibrous cartilaginous capsule enveloped the migrated implant No. 1. Fine connective tissue capsule enveloped specimen No. 1 with resistant bone. The fibers in the underlying bone were coarse, the structure of spongy bone was large-cellular. Implants Nos. 3 and 5 were enveloped in a cicatricial cartilaginous membrane.

The most unfavorable tissue reaction was observed around implant No. 3 (HDII: D ( $\text{Ag}^+$ ): fatty restructuring of the red bone marrow with black incorporations and extremely scanty cells and vessels.

Tissue around implant No. 5 presented as a cicatricial capsule with cartilaginous structures. The underlying bone was characterized by a chaotic trabecular network, uneven mineralization, included cartilaginous cells.

The most favorable reaction of tissues was seen around specimens No. 4 (HDII: D ( $\text{Mo}^+$ )). The fibrous capsule was extremely fine, the adjacent bone had normal structure.

Implants No. 2 (HDII: D ( $\text{Zr}^+$ )) were enveloped in a fine fibrous capsule; the cortical bone was characterized by high mineralization with scanty cell elements. The spongy bone structure was large-cellular, in some cells the myeloid tissue was replaced by fatty tissue with fibrous formations.
